Cloud Computing Facility, Hong Kong

Hi-Tech Composite Covers For High-Tech Cloud Computing Facility In Hong Kong

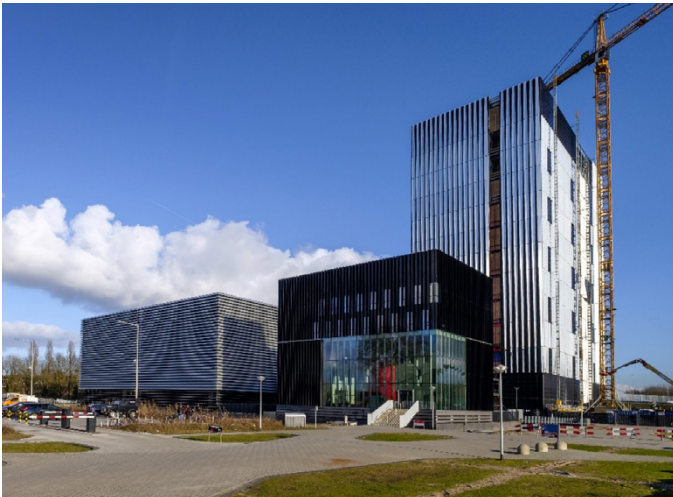
Fibrelite trench covers protect fibre optic cabling at emergency vehicle access point (image used for illustration purposes as actual data centre cannot be shown)

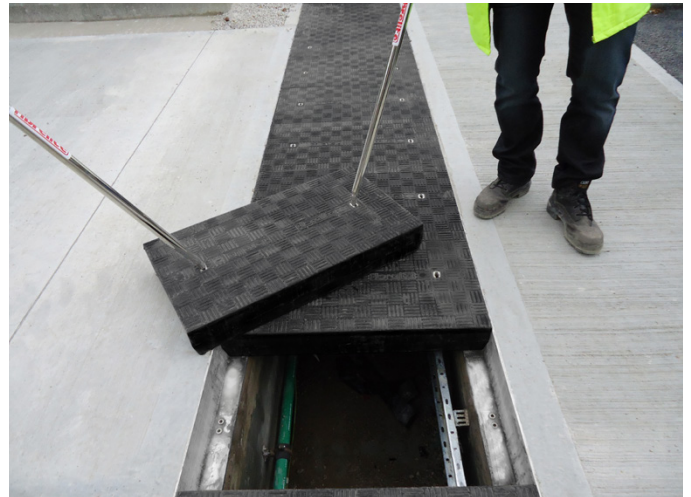
Fibrelite covers are designed to withstand heavy loads and harsh weather conditions for many years (Image of a similar installation used for illustration purposes as actual data centre cannot be shown)

The specified Fibrelite heavy-duty trench covers have a 40-tonne load rating (D400), enabling them to withstand heavy vehicle traffic whilst still being able to outperform concrete on a long-term basis. Designed as a fit and forget product all Fibrelite GRP composite covers are maintenance free corrosion-resistant and ultra-durable.
