Project Overview

Wheatcroft water treatment facility in Scarborough approached Fibrelite looking for a long-term solution to replace their short term steel covers, odour prevention manual handling and security were all important issues.

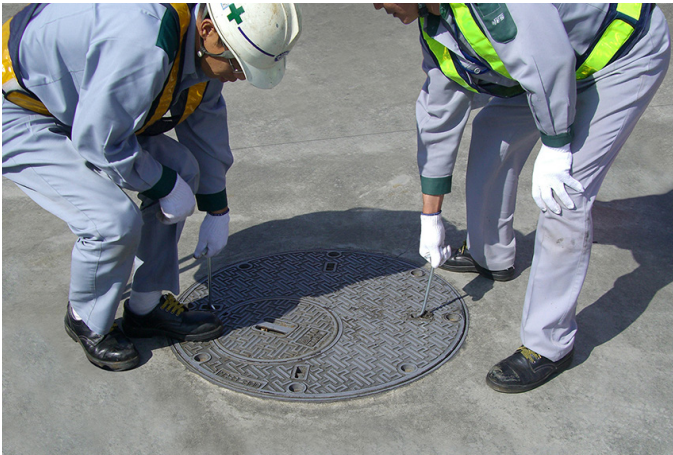
Previously installed heavy metal covers with compromised lifting technique

The previously installed steel covers had a life span of 18 months due to the corrosive gases from the waste water material in the pipeline, causing erosion of the covers. One critical issue was preventing the odour from the pipeline escaping, manual handling and security were key issues as well.

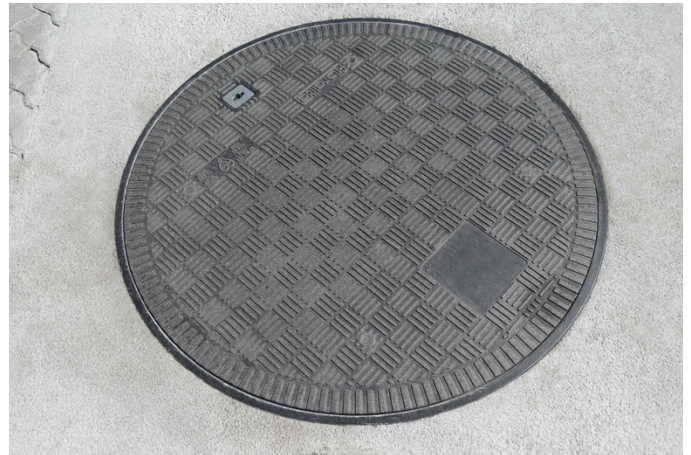
Fibrelite installed (FL 90) with a 40-tonne load rating

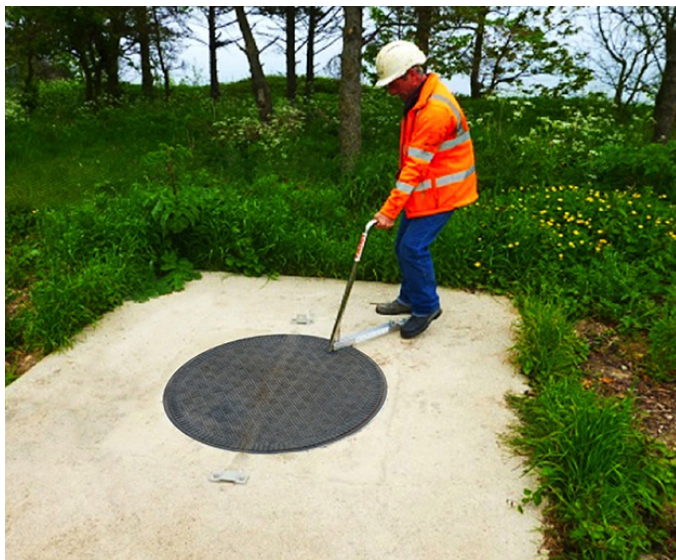
Fibrelite's lightweight covers

Fibrelite's lightweight, watertight manhole covers, offer easy access for operators at Wheatcroft water treatment facility preventing manual handling issues, for extra security a bar was installed over the cover. Fibrelite's covers are corrosion resistant and odour tight making them the perfect solution.

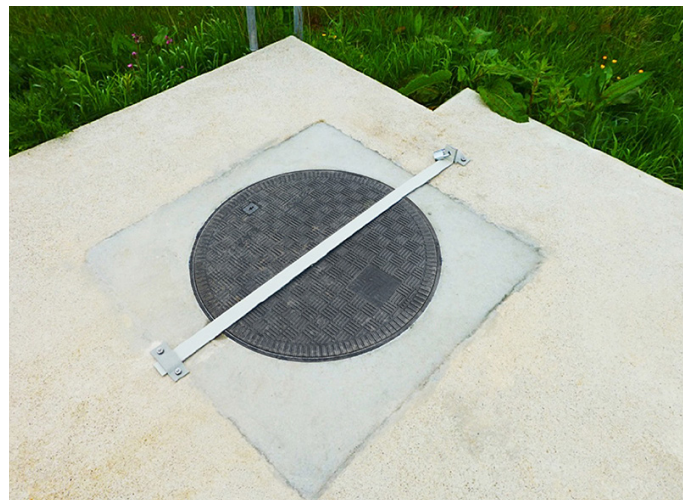
Fibrelite cover with bar installed over for extra security

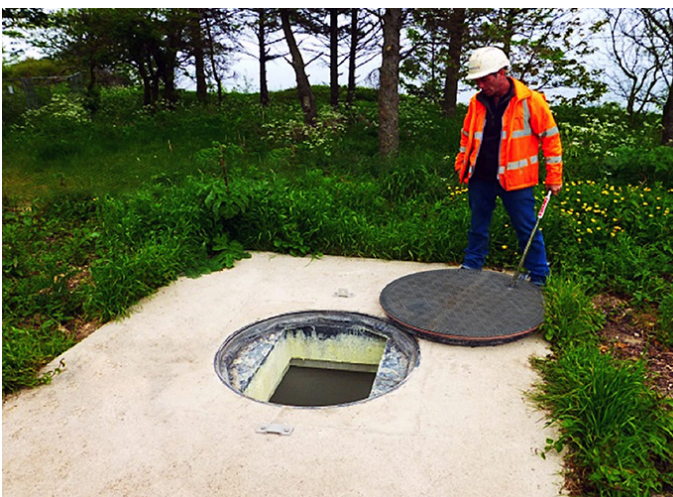
Eliminating manual handling issues

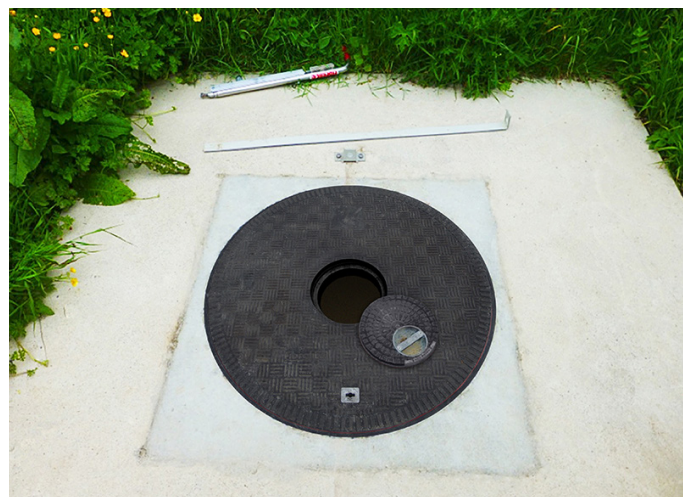
Fibrelite's FL90 covers with inspection port

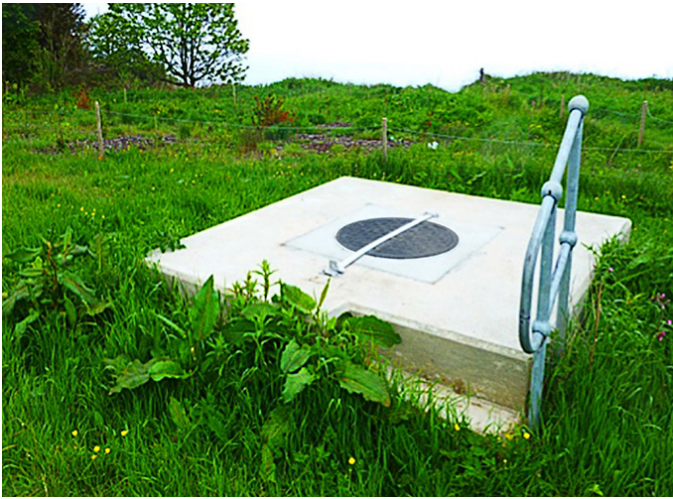
Fibrelite's cover with easy access installation

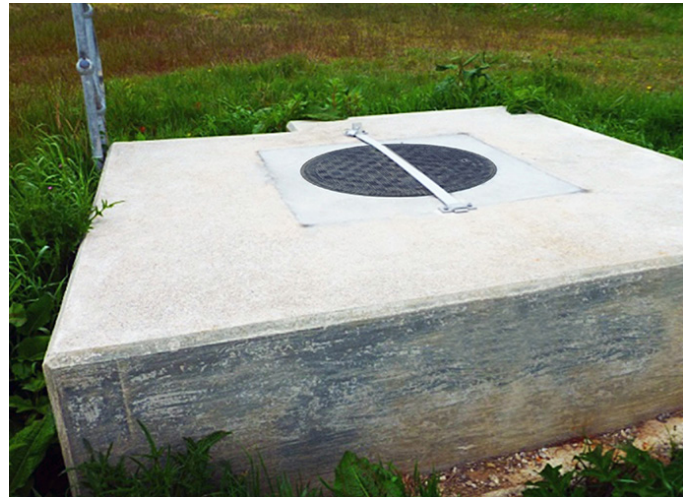
Fibrelite cover with easy access installation
